Manhole Inspection Summary

Manhole # S51CC_014MH

Insp Date: **2/25/08 12:05 PM**

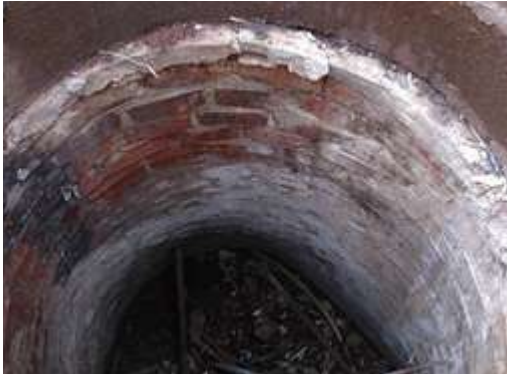
Defect 2

Condition: ☐ Sound ☐ Cracked ☐ Root Intrusion ☒ **Loose Brick** ☒ **Deteriorated**

Infiltration: ☐ None ☒ **Joint** ☐ Cracks ☐ Mortar ☐ Roots ☐ Wall

adjustment joint

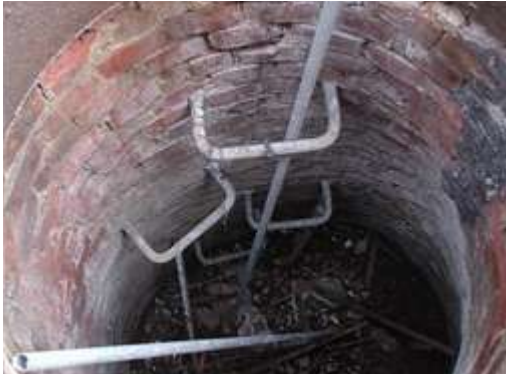
Defect 1

Infiltration: ☐ None ☐ Joint ☐ Cracks ☐ Mortar ☐ Roots ☒ **Wall**

corbel wall
